## **Paint Survey of Patriot Vehicles**

**ARL-TR-3909**

**September 2006**

On the 24th and 25th of January 2006, a paint survey of Patriot vehicles was conducted at the Lower Tier Project Office, Fort Bliss facility located in El Paso, TX. The survey's intent was to inspect paint delamination at the seam line on an engagement control system (ECS), further document any paint defects on the other Patriot vehicles, and provide recommendations on materials and procedures to prevent, repair, and control the observed damage. The coating system on the ECS was the water-reducible wash primer Kem Aqua supplied by Sherwin-Williams; epoxy primer was MIL-DTL-53030 supplied by DEFT; and the topcoat was MIL-DTL-53039A supplied by Hentzen.

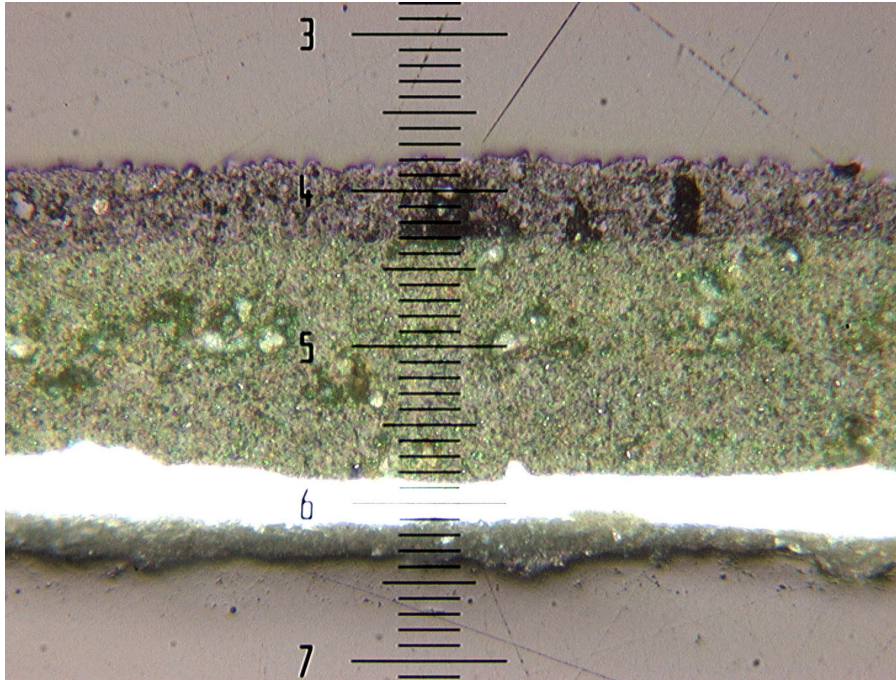
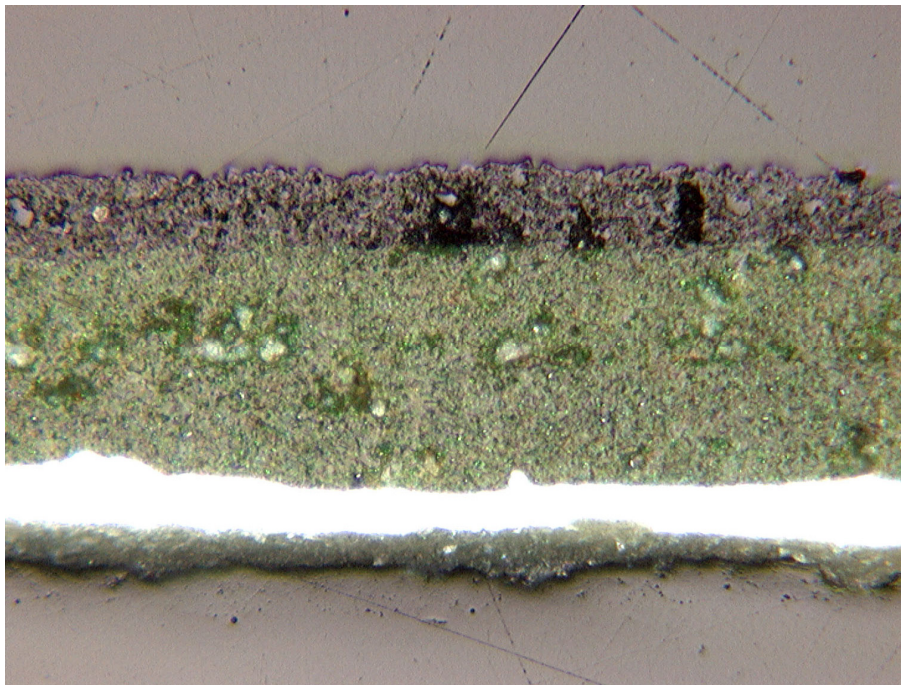
The micrographs presented in figures 1–2 depict the coating layers present on the paint chip. The top two layers appear to be black and green chemical agent resistant coating topcoat. The third layer down appears to be a white primer, and the bottom layer appears to be the water-reducible wash primer (Sherwin Williams' Kem Aqua). No polyester filler was detectable on the chip, as noted by RDEC. In figure 1, each division of the ruler is equivalent to 0.0004 in. The average thickness of the water-reducible wash primer remaining on the chip is ~0.001 in.

Figure 1. Micrograph of paint chip removed from Patriot ECS shelter with water-reducible wash primer; 1 div = 0.004 in.

Figure 2. Micrograph of paint chip removed from Patriot ECS shelter with water-reducible wash primer.

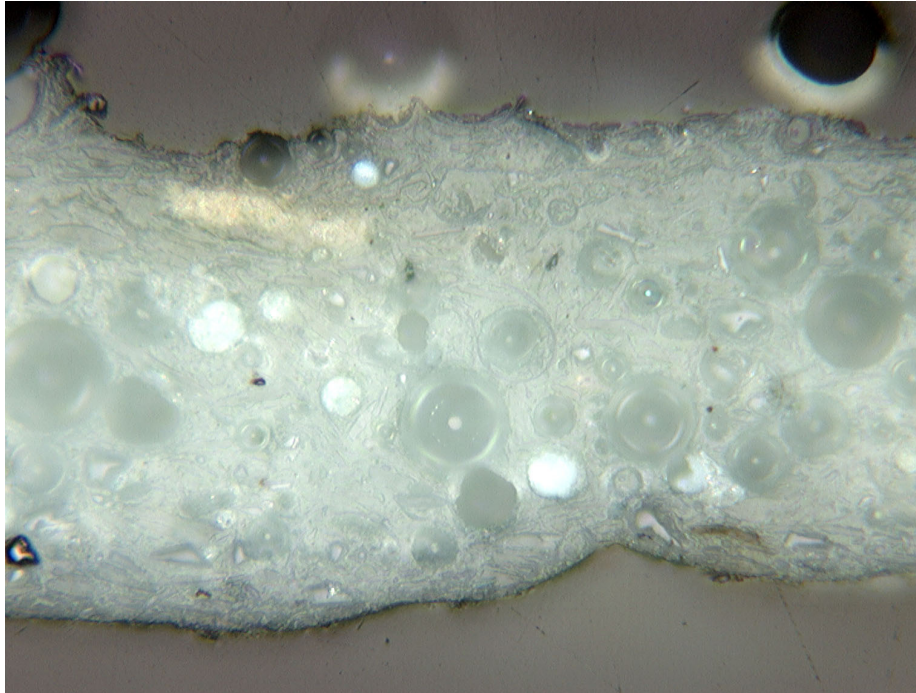
Figure 3 is a micrograph of the polyester filler. It does not appear that any of the polyester filler material shown in figure 3 is present underneath the wash primer layer on the paint chip. The absence of any polyester filler on the paint chip indicates a lack of adhesion between the water-reducible wash primer and the polyester filler material.

Figure 3. Micrograph of polyester filler removed from the Patriot ECS shelter with water-reducible wash primer.

The results of this analysis indicate an adhesive failure between the water-reducible wash primer and the polyester filler. Possible causes include material incompatibility between the water-reducible wash primer and the polyester filler or contaminants on the surface of the polyester filler prior to application of the water-reducible wash primer. The paint chip from the new wash primer showed four layers of coating, while the control sample showed three coatings.

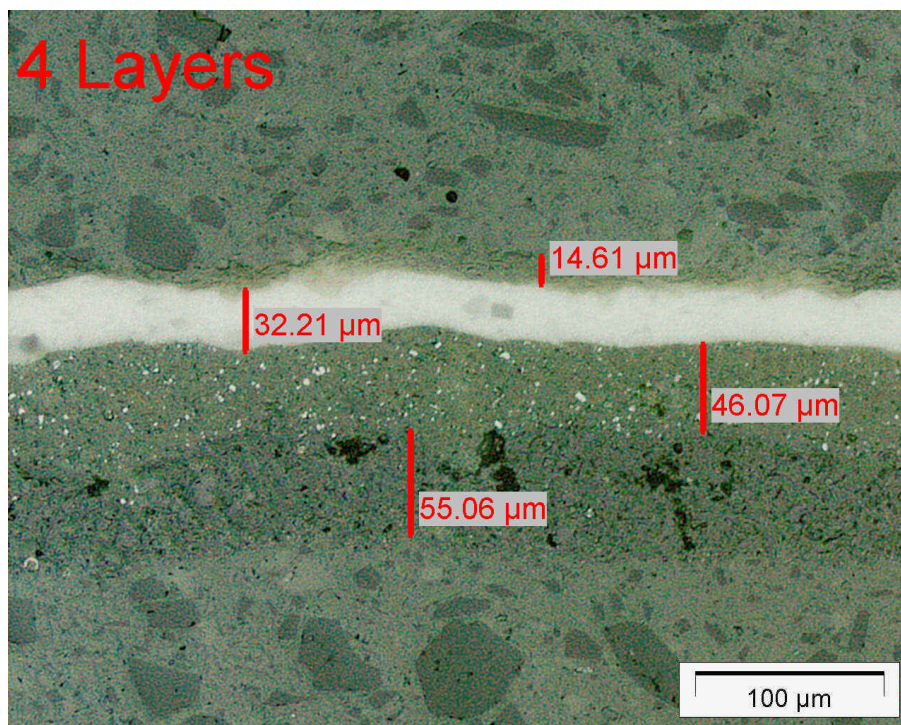
Figure 4. Micrograph of paint chip removed from Patriot ECS shelter with water-reducible wash primer.

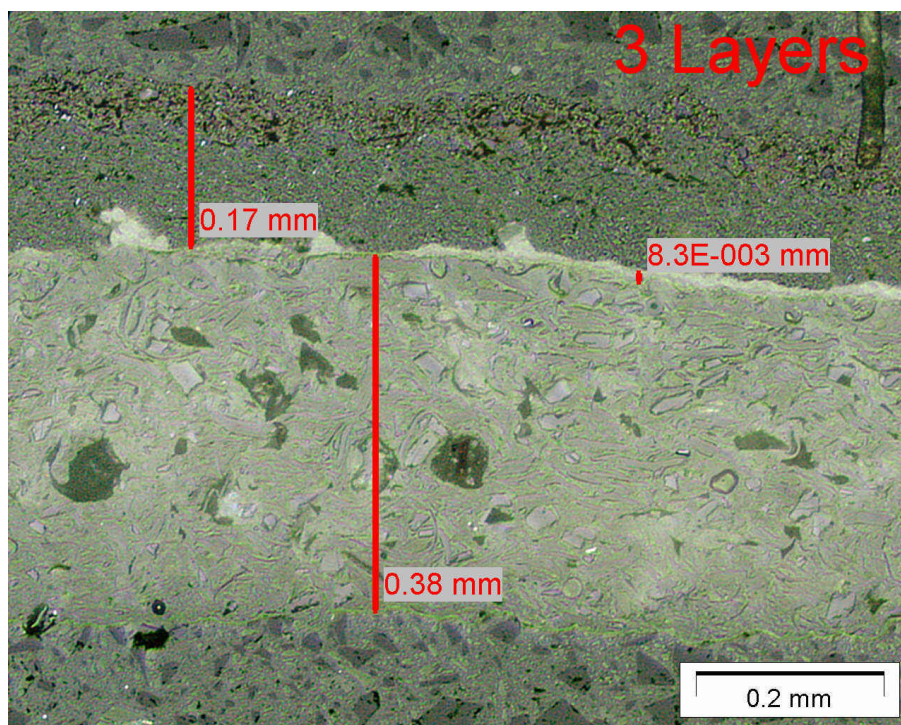
Figure 5. Micrograph of paint chip removed from Patriot communications relay group (CRG) shelter with control wash primer.

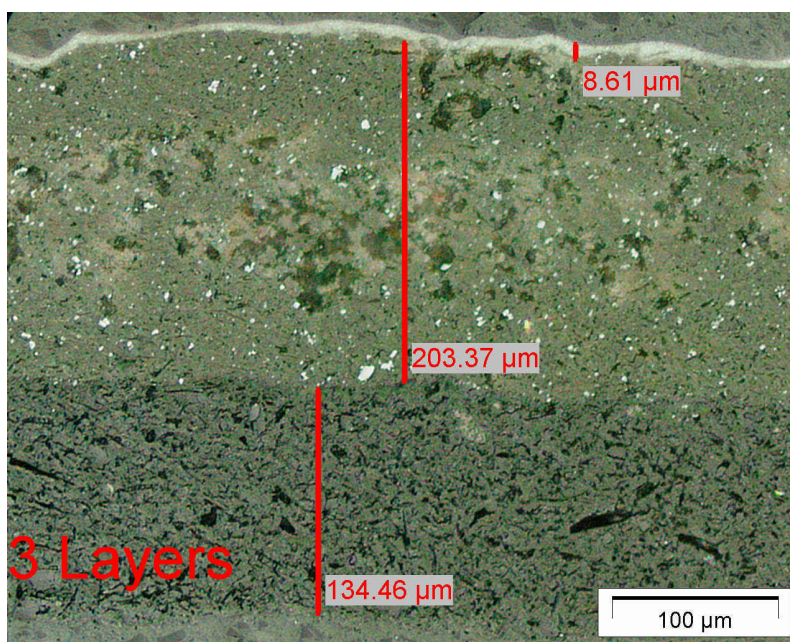
Figure 6. Micrograph of paint chip removed from Patriot ECS shelter with control wash primer.

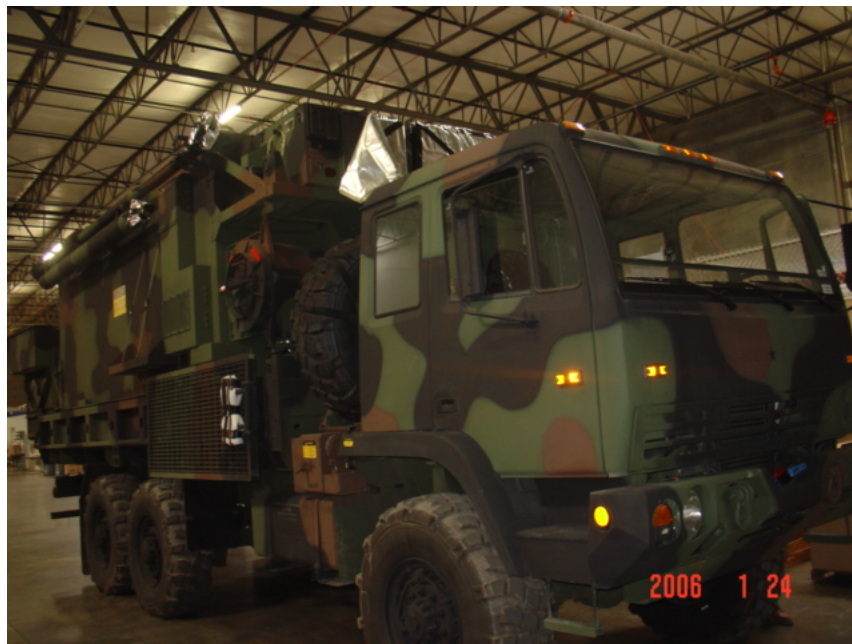
1. ECS, serial no. 720007, overhaul date 10/05 (figure 7). No paint failure was noted, and the overall impression of the vehicles was very good.

Figure 7. ECS; serial no. 720007; overhaul date 10/05.

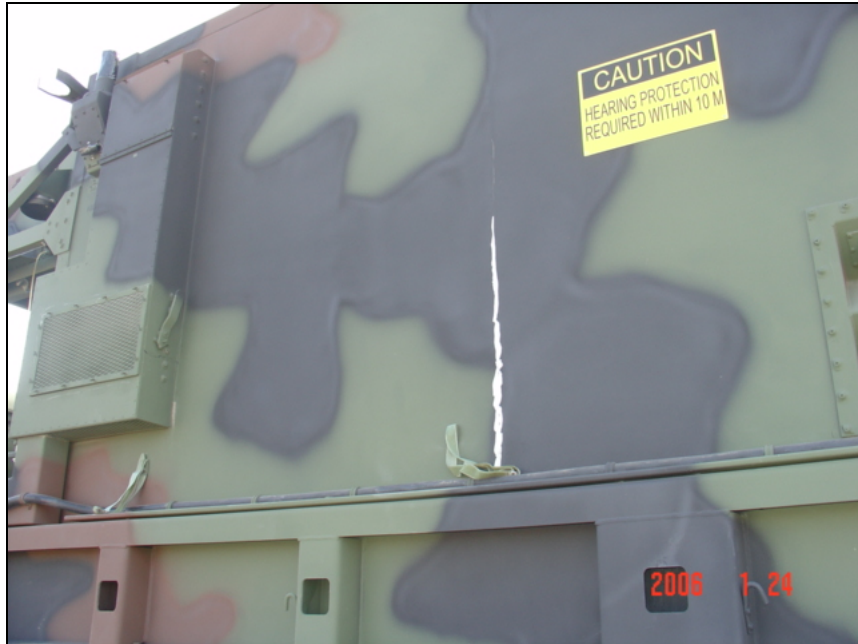
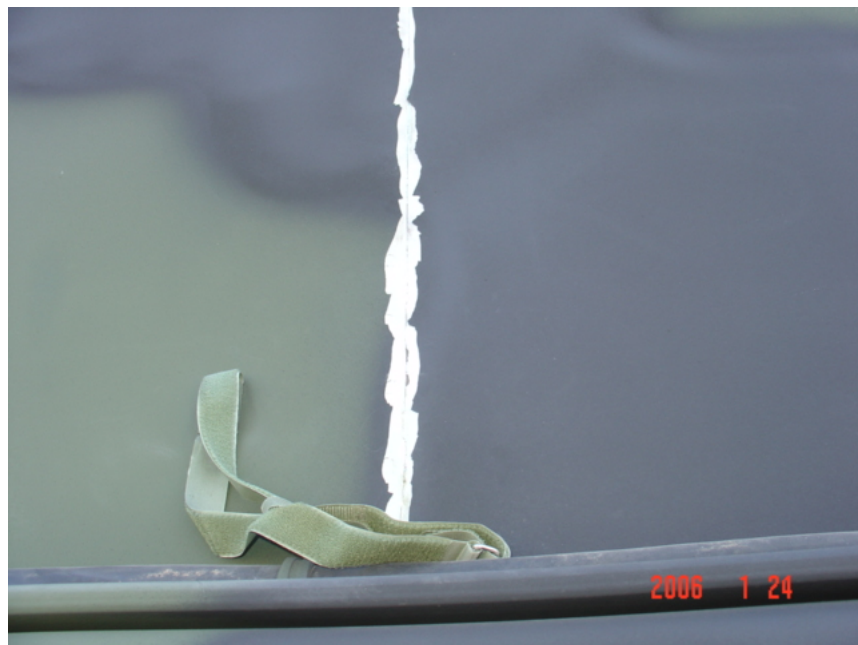
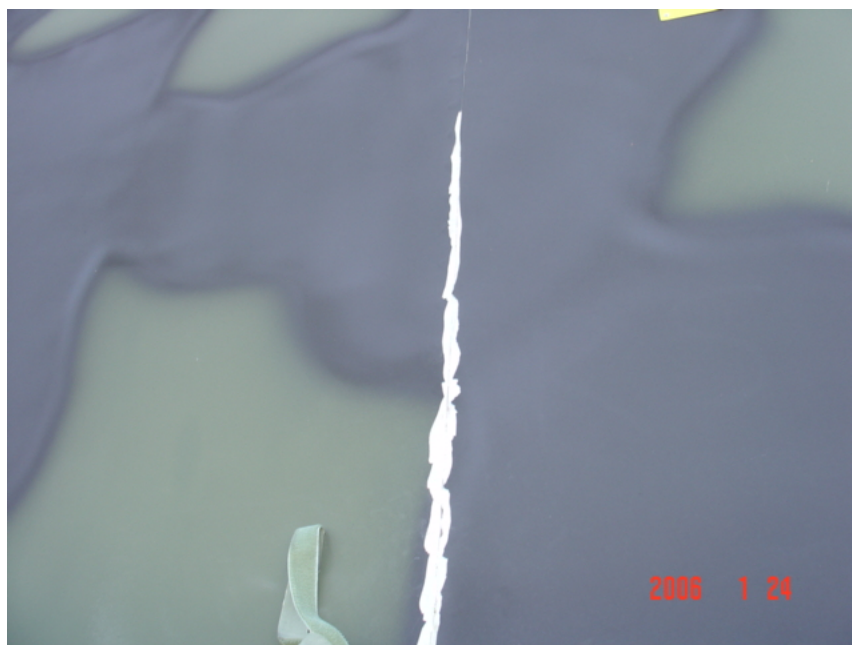
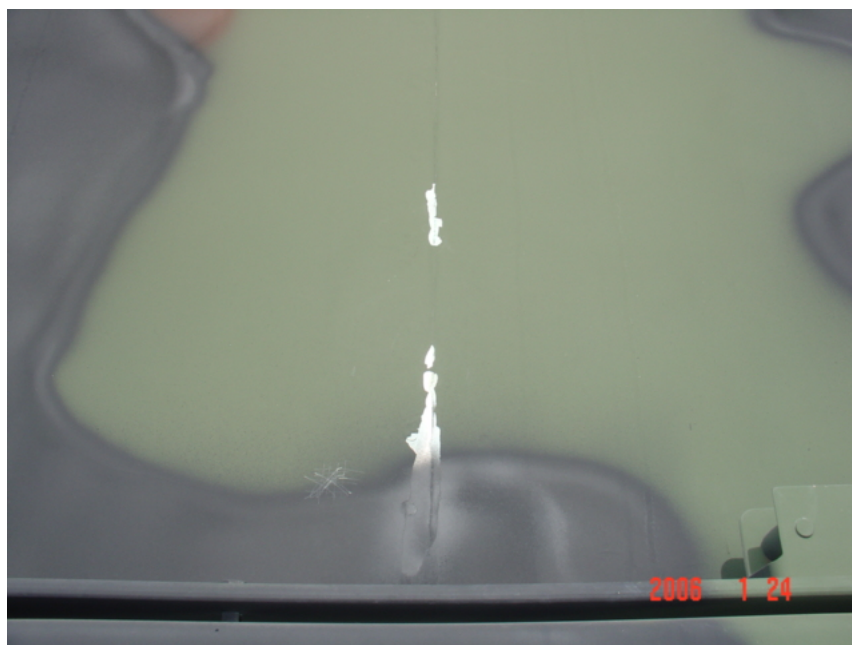
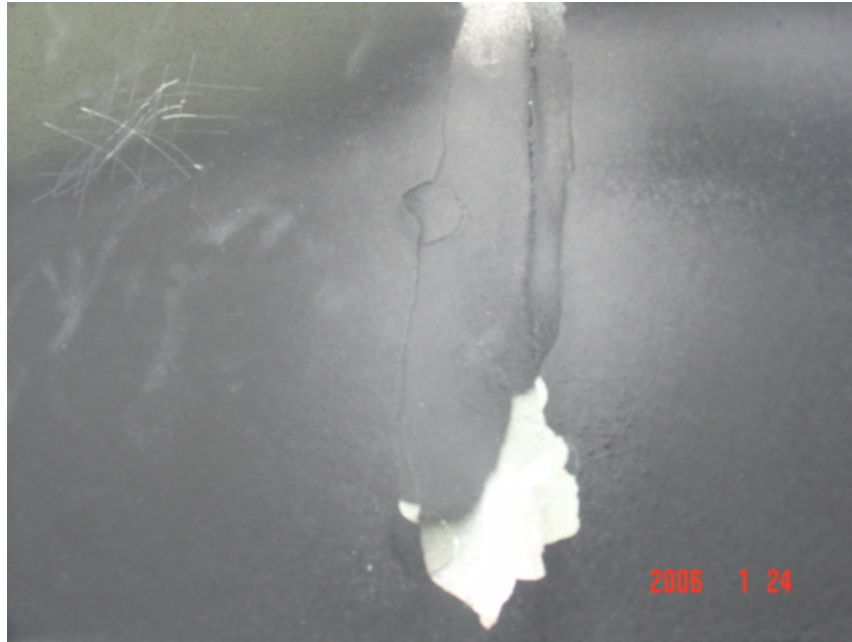
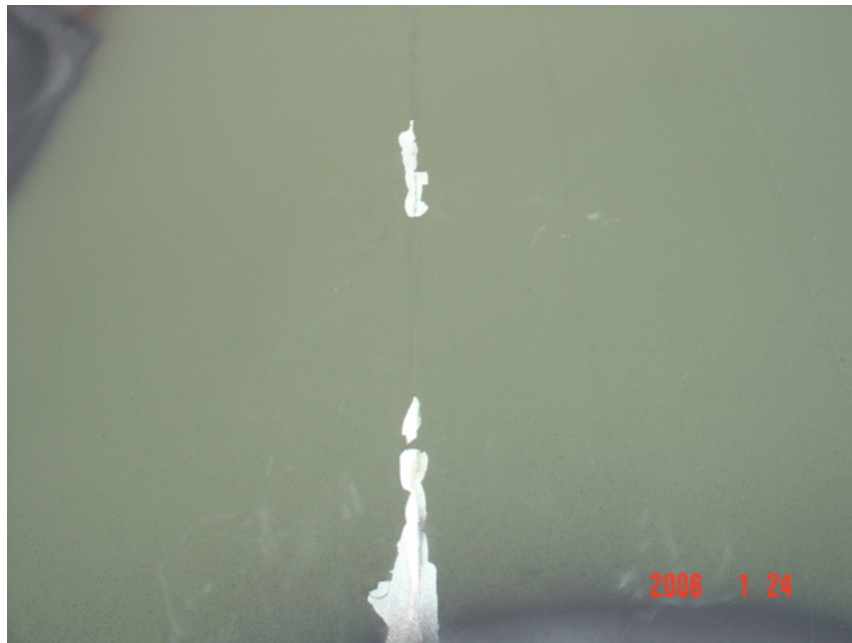
2. ECS, serial no. 630106, overhaul date 05/05 (figures 8–13). There were two areas of paint adhesion failure on the outside vertical seam where the paint (1/4 –1 in) had peeled away or delaminated. Film delamination occurred only at the seam and only where the polyester filler was applied. Rivet head outlines could be seen along the entire seams. Expansion and contraction forces along the butt seam may be a contributing factor. This failure appeared to be localized at the weakest interface along the butt seam (i.e., between primer and body filler or substrate and body filler). Mechanical forces causing flex of the substrate (evidenced by the rivet heads) distorted the coatings. The coatings then separated at the weakest interface that appeared to be the body filler – substrate interface. This Patriot ECS unit was painted using the low volatile organic compound (VOC) water-reducible wash primer at Letterkenny Army Depot, Chambersburg, PA, and fielded at Fort Bliss, TX. The two areas of concern were sections of the shelter where the walls were replaced. The walls were bonded using a polysulfide sealer and a polyester filler. The filler material appeared to have a heavy film. Dry film thickness measurements (1 mil = 0.001 in) were taken at four different areas, with data recorded in table 2. Due to high temperatures, the shelter walls expanded, causing the paint filler to crack and peel along the butt joints where replacement wall sections met older wall sections. A knife blade easily removed painted filler along the edges for laboratory analysis.

Figure 8. ECS right side; serial no. 630106; overhaul date 05/05.

Figure 9. ECS left side; serial no. 630106; overhaul date 05/05.

Figure 10. ECS after tape pulled off; serial no. 630106; overhaul date 05/05.

Figure 11. ECS before tape pulled off; serial no. 630106; overhaul date 05/05.

Figure 12. ECS area with bondo; serial no. 630106; overhaul date 05/05.

Figure 13. ECS before tape pulled off; serial no. 630106; overhaul date 05/05.

- It appears that the construction method where a damaged wall section is cut out and replaced using a butt seam is a potential weak link where expansion and contraction can cause cracking or peeling at the weakest place.

- If aesthetics is insisted for the seam line, ARL would suggest using epoxy fillers with a proven record. Additional test/evaluation with various water immersions at room and higher temperatures would be required and evaluated for 6 months by EMMAQUA.

- In conclusion, an evaluation of the lap seam vs. the butt seam construction method should take place. It is too early to say definitively that the lap seam method will cure seam cracking, but early evidence may offer a possible solution. A test utilizing a lap seam construction on an ECS or CRG is recommended. It should be noted that out of all shelters, only two exhibited the butt seam cracking failure. Additional testing of the low VOC wash primer on full-size shelters would also assist in the overall data assessment. If additional testing is performed, some units with both the lap seam construction and the butt seam construction should be painted with the low VOC, water reducible wash primer.

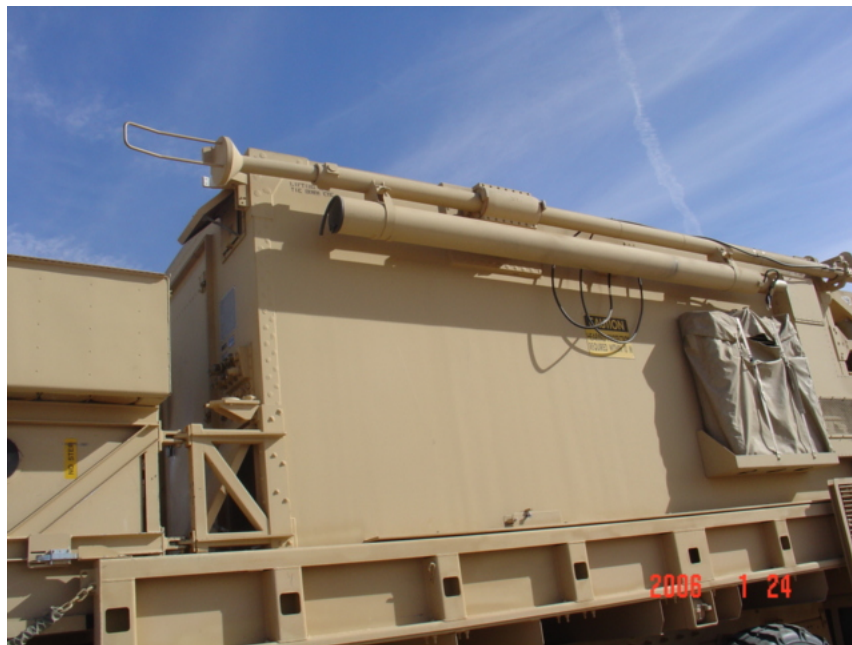
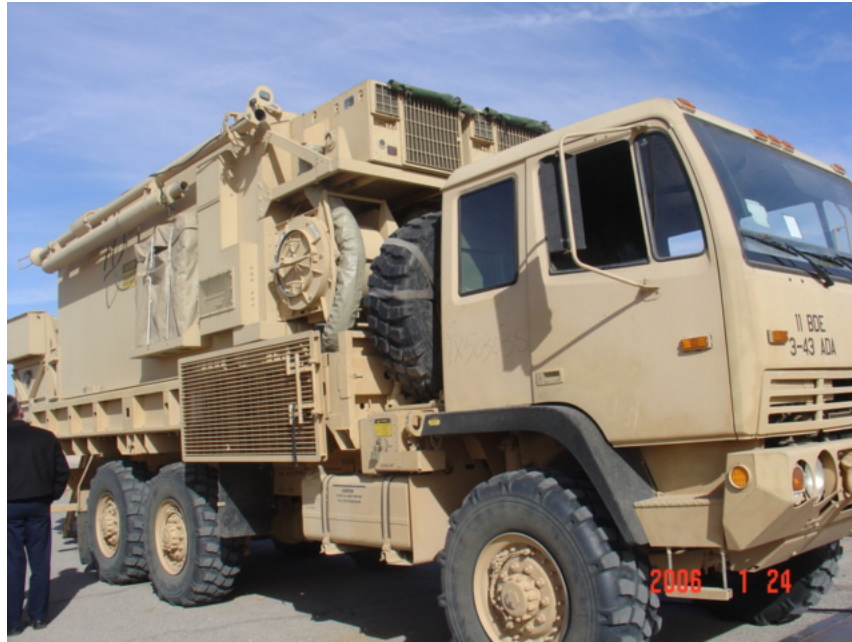
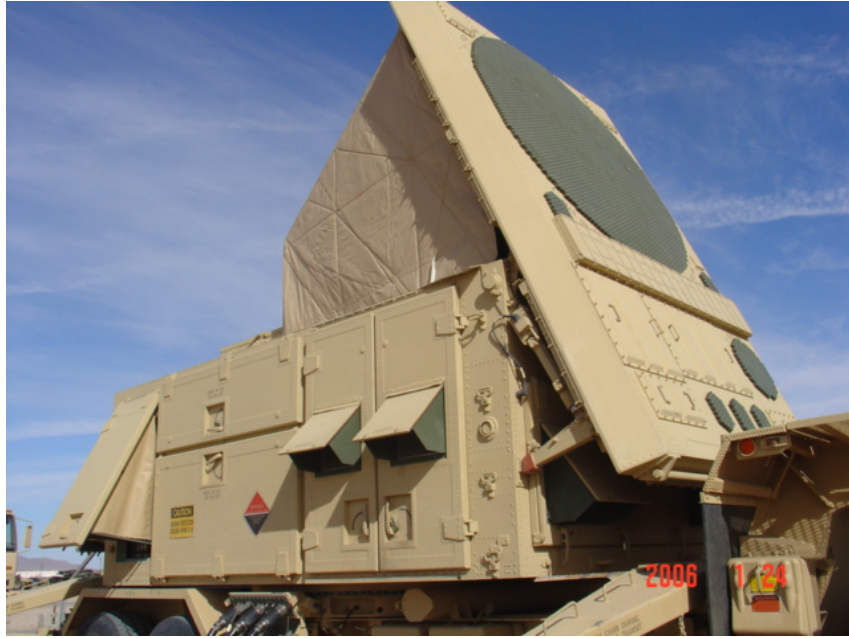
3. ECS, serial no. 700117, no overhaul date provided. No paint failure was noted, and the overall impression of the vehicle was good.
4. ESC, serial no. 810003, overhaul date 06/03 (figures 14–17). No paint failure was noted, and the overall impression of the vehicle was very good.

Figure 14. ESC rear images; serial no. 810003; overhaul date 06/03.

Figure 15. ESC full view; serial no. 810003; overhaul date 06/03.

Figure 17. ESC; serial no. 810003; overhaul date 06/03.

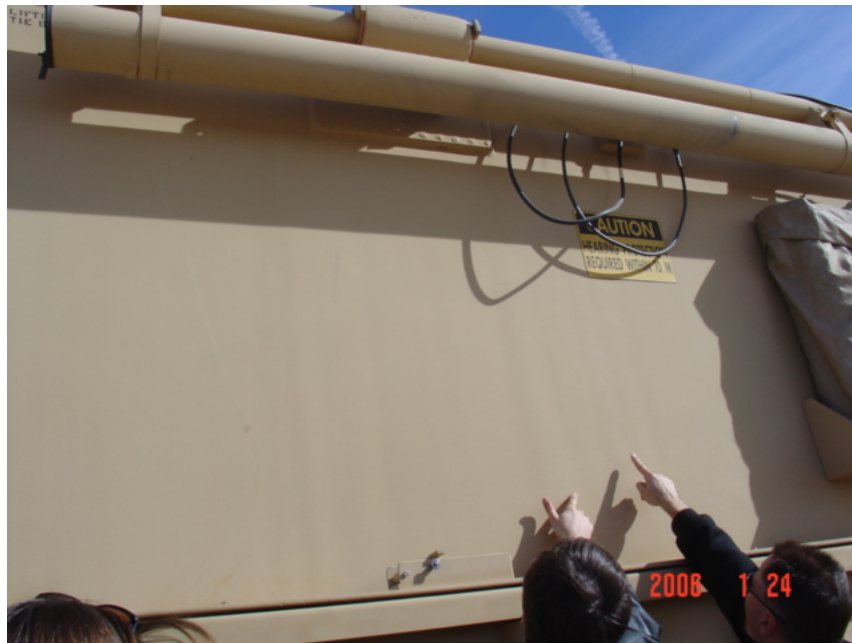
Figure 16. ESC seam with cracks; serial no. 810003; overhaul date 06/03.

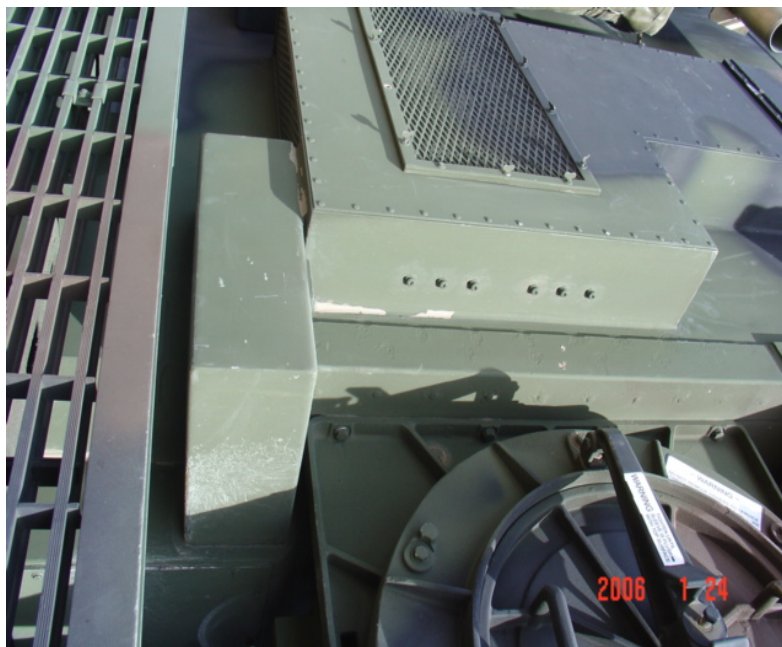
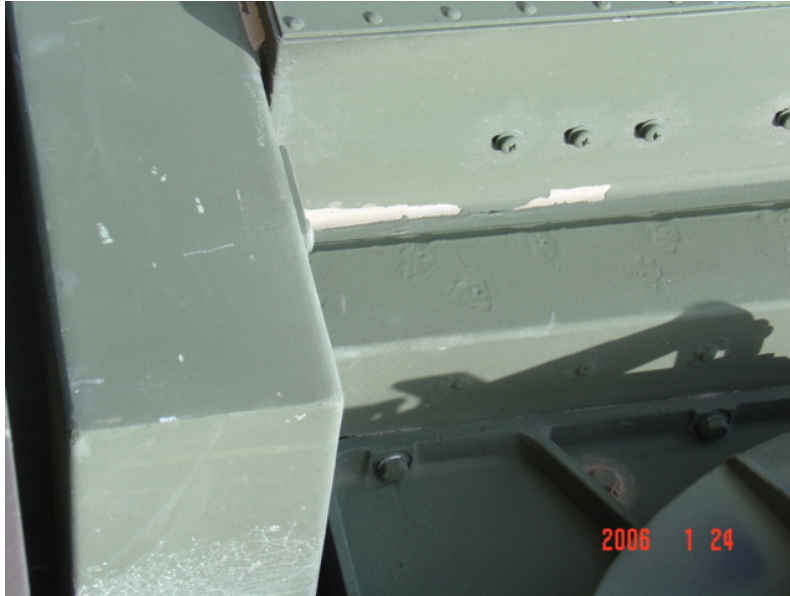
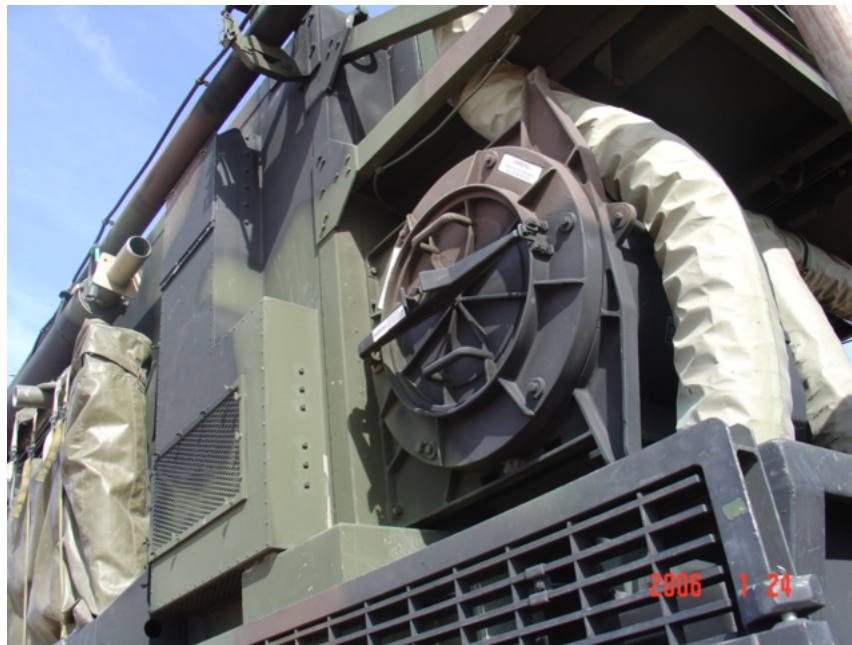
5. SRPT, serial no. 620453, overhaul date 09/05. No paint failure was noted, and no filler material was used.
6. Raytheon. Paint failure was noted along sealed edges.
7. CRG, serial no. 620456, overhaul date 02/05 (figures 18–21). No paint failure was noted, and the overall impression of the vehicle was good.

Figure 18. CRG; serial no. 620456; overhaul date 02/05.

Figure 19. CRG; serial no. 620456; overhaul date 02/05.

Figure 20. CRG left side; serial no. 620456; overhaul date 02/05.

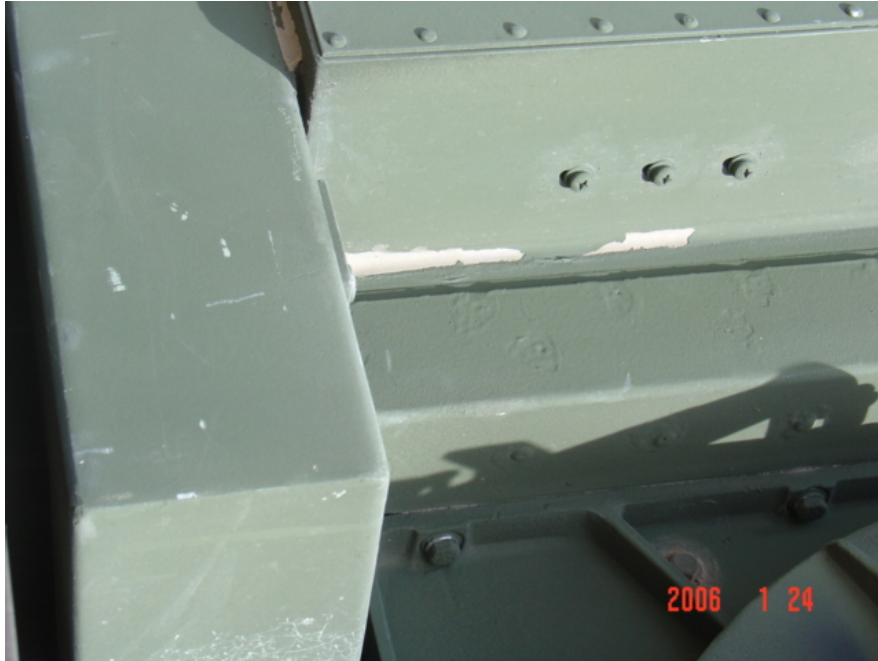
Figure 21. CRG areas showing paint chip; serial no. 620456; overhaul date 02/05.

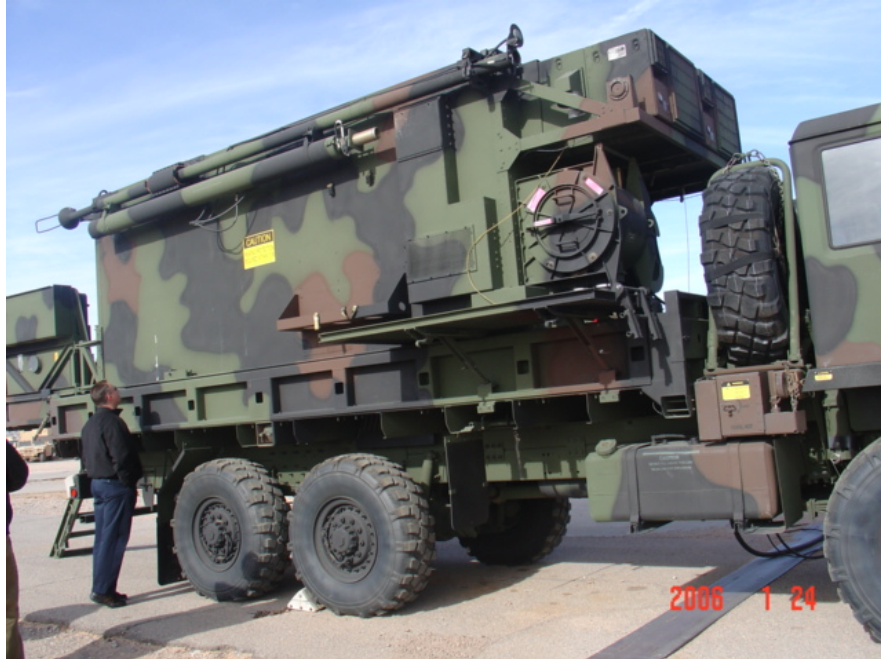
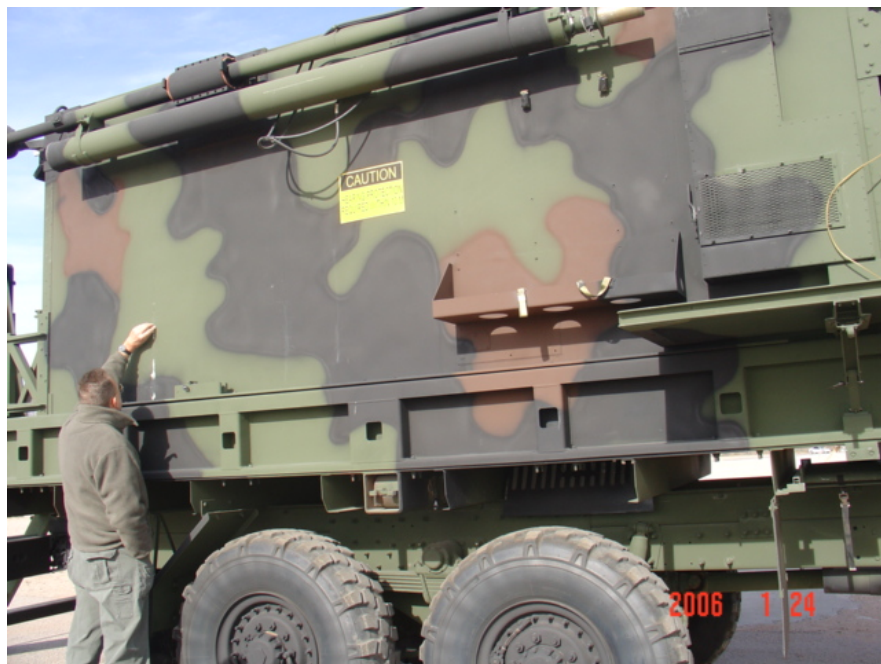
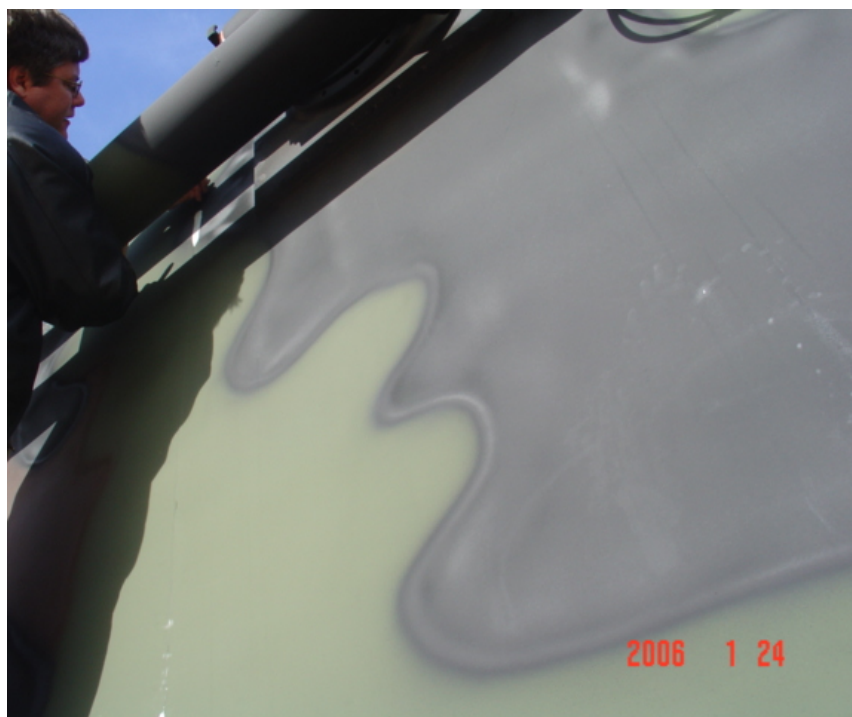
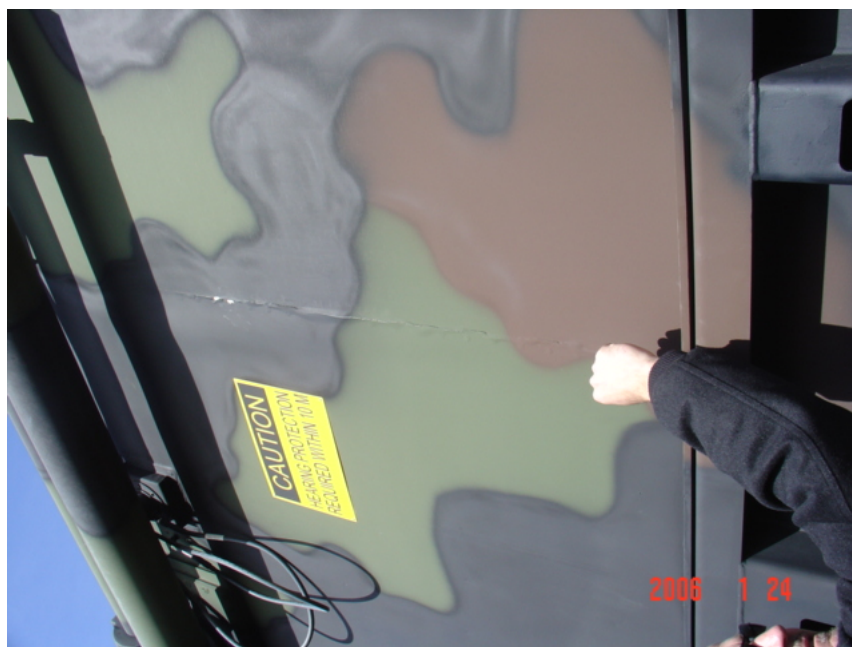
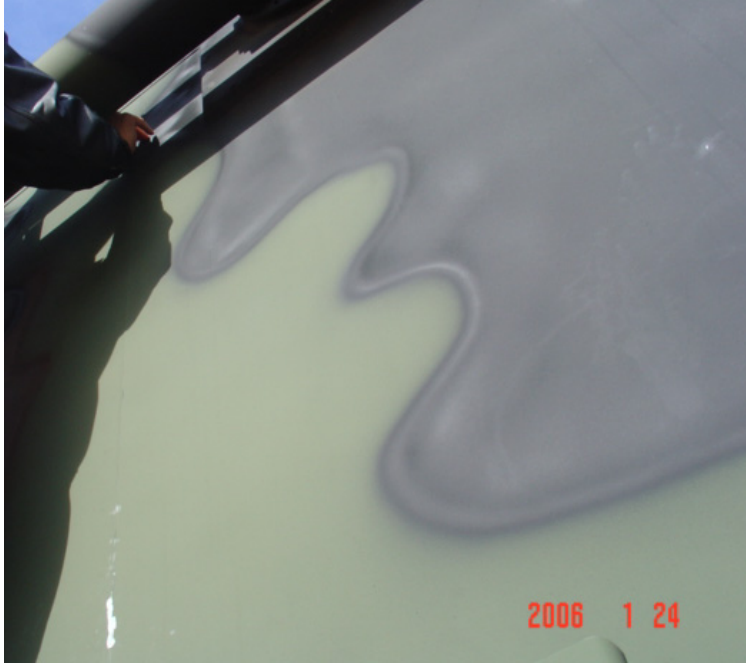
8. CRG, serial no. 680516, overhaul date 08/05. No paint failure was noted, and the overall impression of the vehicle was good.
9. CRG, serial no. 620456, overhaul date 05/05 (figures 22–26). There were areas of paint filler adhesion and damage to the exterior where the paint and filler (1/4–1 in) had peeled away or delaminated. Rivets appeared loose. The paint, filler material, and sealant along the seam were removed. A knife blade easily removed paint and filler along the edges for laboratory analysis. This vehicle was painted with the current paint system but exhibited paint failure along the butt seam joint similar to the low VOC wash primer trial unit.

Figure 22. CRG paint chip from a distance; serial no. 620456; overhaul date 05/05.

Figure 23. CRG paint being removed; serial no. 620456; overhaul date 05/05.

Figure 24. CRG delaminated area; serial no. 620456; overhaul date 05/05.

Figure 25. CRG delaminated paint area; serial no. 620456; overhaul date 05/05.

Figure 26. CRG delaminated paint being removed; serial no. 620456; overhaul date 05/05.

- This travel mission showed that the butt seam process on ECS and CRG shelters is a cause for concern with both paint systems (either the current acid wash pretreatment or the new low VOC wash primer). One unit with a similar defect to the trial unit was found using the paint system with the current wash primer.

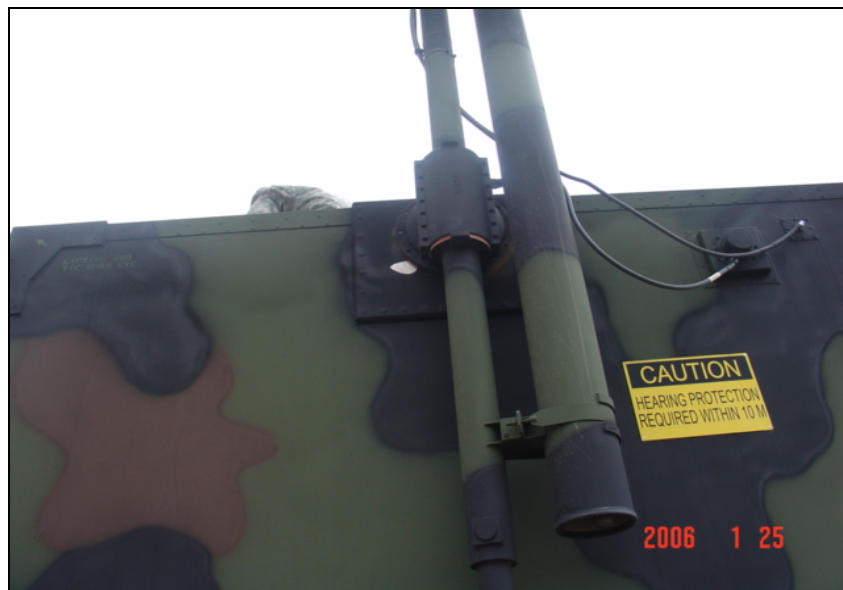
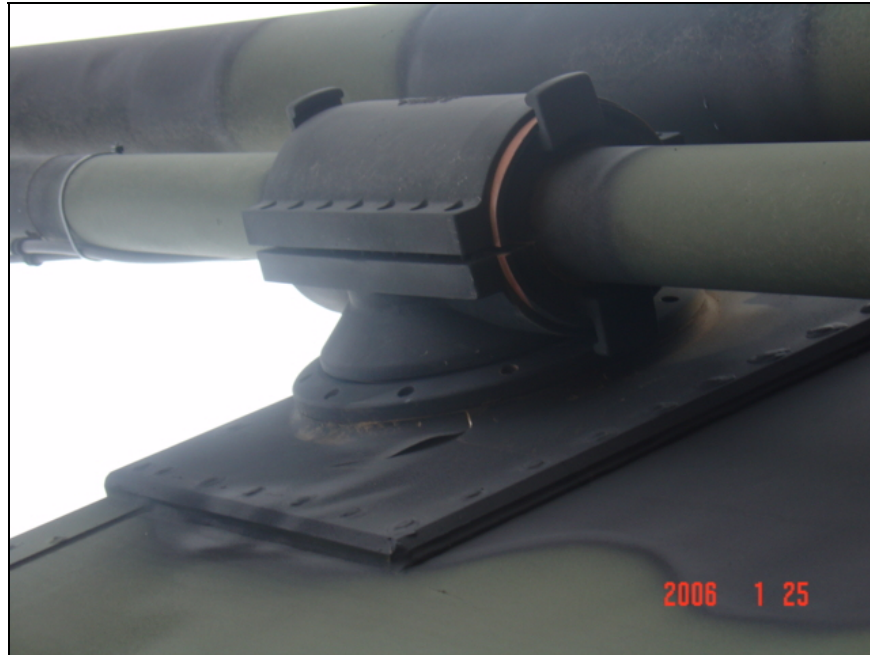
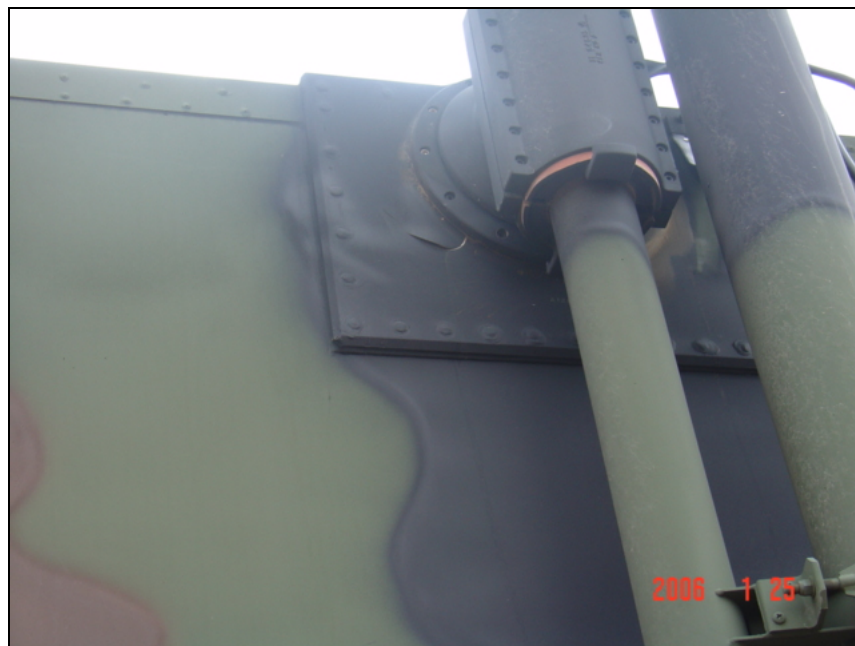
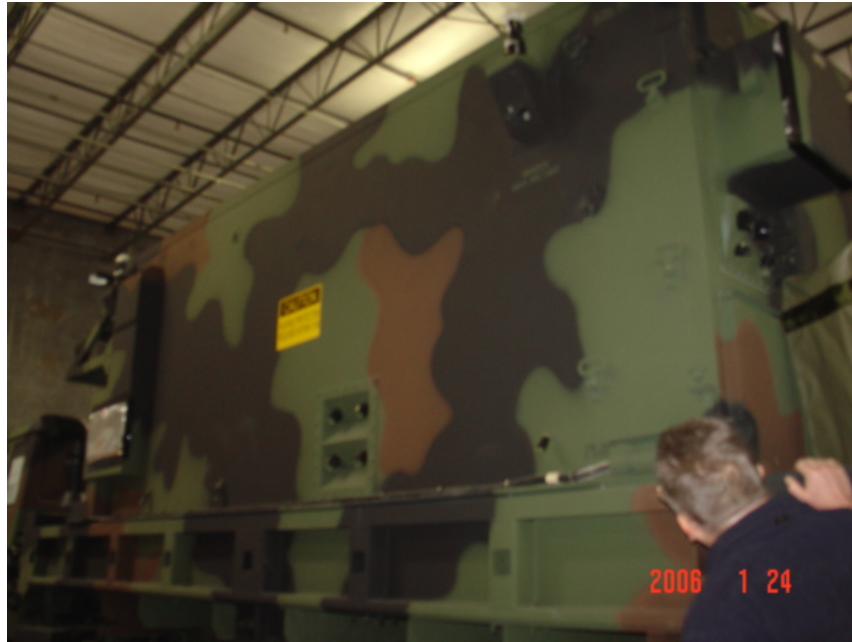
15. SRPT, serial no. 660110, overhaul date not provided. No paint failure was noted, and the overall impression of the vehicle was good.
16. ECS, serial no. 810166, overhaul date 10/04 (figures 27–30). No paint failure was noted on the shelter or vehicle; antenna mast attachment plate had cracked paint. Paint system completely separated from the substrate. Chip was removed for analysis. No visible evidence of wash primer appeared. Paint chip removal showed bare metal (aluminum).

Figure 27. ECS paint failure; serial no. 810166; overhaul date 10/04.

Figure 28. ECS antennae mast attachment; serial no. 810166; overhaul date 10/04.

Figure 29. ECS antennae showing paint delamination; serial no. 810166.

Figure 30. ECS multiple layers of paint; serial no. 810166.

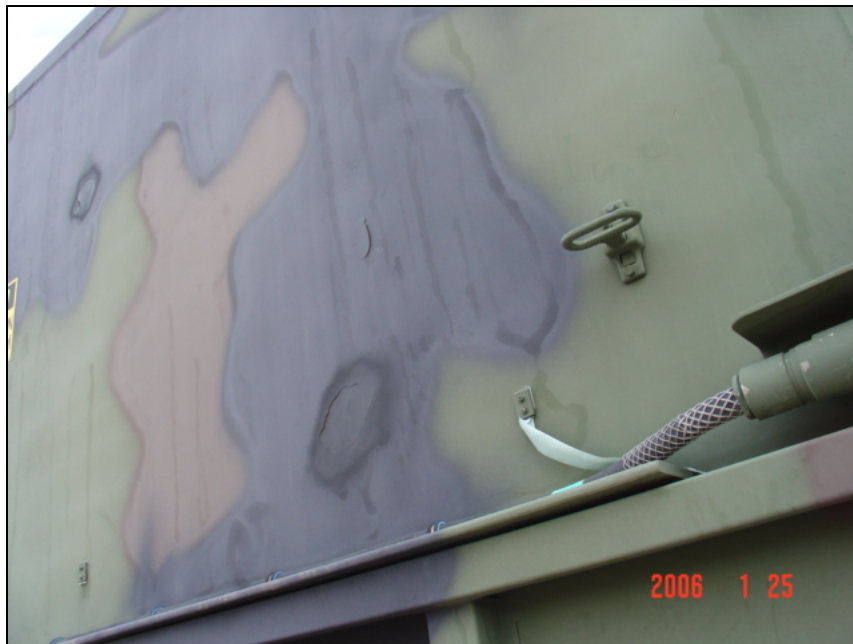
17. ECS, serial no. 780335, overhaul date 10/01. Front bumper on truck had peeling of nonskid paint; otherwise, no paint failures were noted on the shelter.
18. ECS, serial no. 600077, overhaul date 06/99 (figure 31). Twelve noted areas of paint defects were noted where paint had either cracked or peeled.

Figure 31. ECS paint delamination; serial no. 600077; overhaul date 06/99.

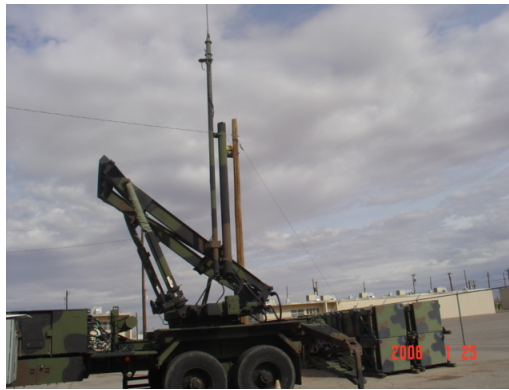
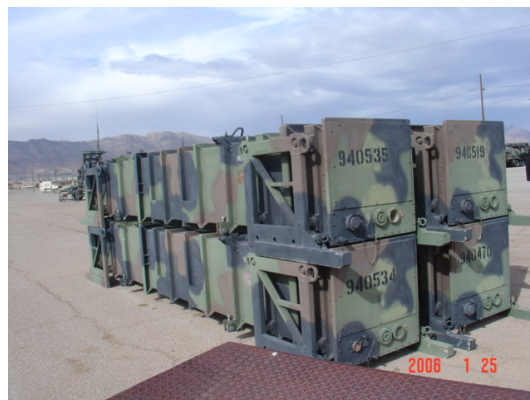
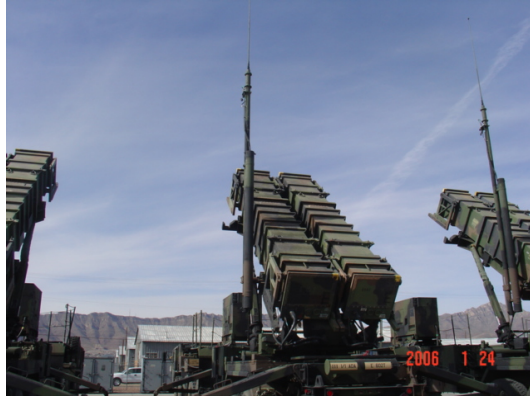
1. Fort Bliss uses Rexcel's Aqua Strip solvent, a hazardous air pollutants (HAPs)-free, water-soluble solvent for paint thinning and cleaning purposes, instead of MIL-T-81772.
2. For RECAP (RECAPITALIZATION), individual metal parts are sandblasted. Plastic media is used on aluminum and grit no. 50 for steel.
3. Fort Bliss specializes in RECAP of the Patriot launchers (figures 32–34). There was one instance where the launcher bed was heavily corroded. The area was exposed, water had settled, and there was no drainage.
